**NASA TECHNICAL NOTE**

**NASA TN D-8411**

**EFFECT OF LOW-VELOCITY IMPACT DAMAGE  
ON THE COMPRESSIVE STRENGTH OF  
GRAPHITE-EPOXY HAT-STIFFENED PANELS**

*Marvin D. Rhodes, Jerry G. Williams,  
and James H. Starnes, Jr.*

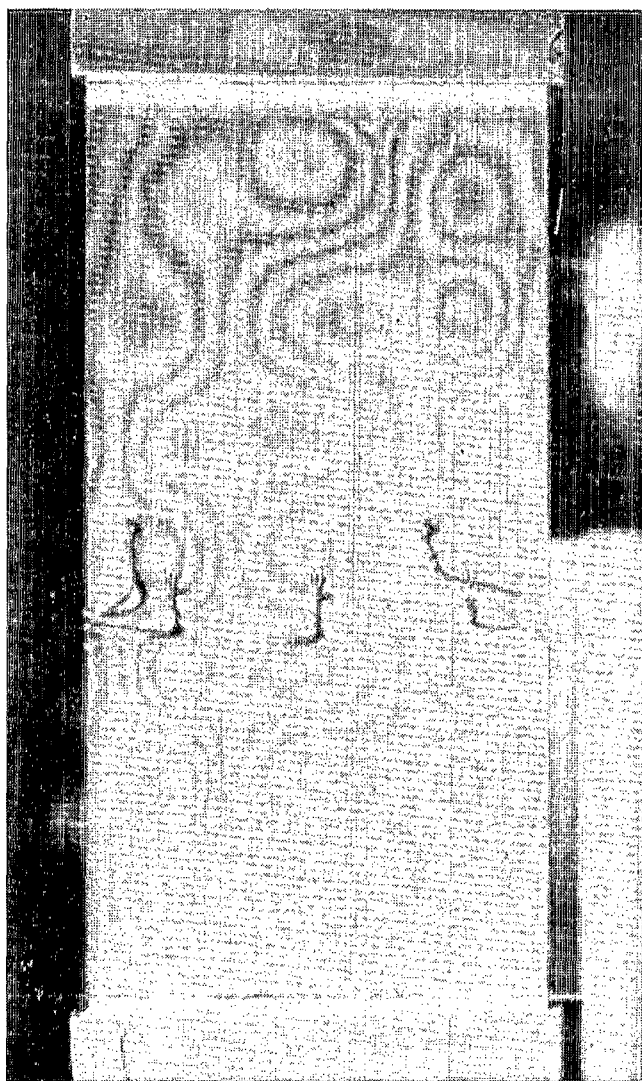
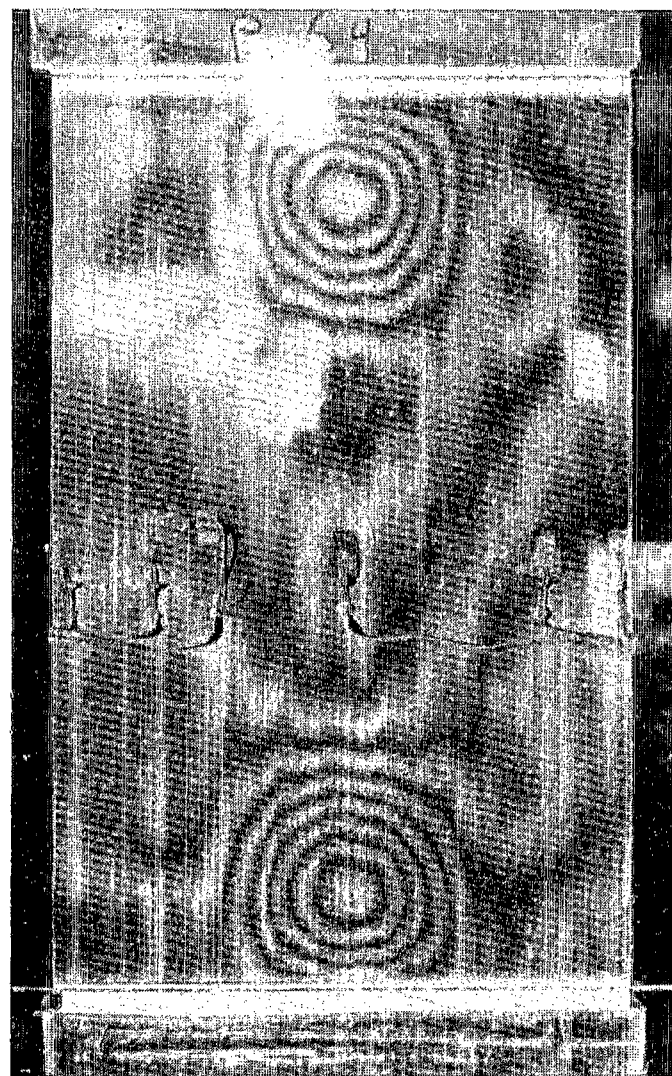
Undamaged panels.- Three panels of design A and four of design B were tested in the undamaged condition to evaluate panel behavior due to applied axial compressive load. The response of each panel to the indicated applied load, or strain, is presented in table II. The design A panels buckled near the design strain of 0.0034 and exhibited postbuckling behavior. The design B panels exhibited strength failure near the design strain of 0.0080 prior to buckling. Photographs of a typical normal displacement field as indicated by the moiré-fringe pattern for both design configurations are shown in figure 3. Test panel A1 (fig. 3(a)) has a fully developed buckle pattern at an imposed strain of 0.0036. Test panel B2 (fig. 3(b)) is shown at an imposed axial strain of 0.0079 which is near the strain at which the panel exhibited failure. The pattern seen at the ends of the panel is the result of in-plane restraints imposed by the flat-end test condition (ref. 2).

(a) Panel A1 designed for strain of 0.0034  
loaded to strain of 0.0036.

(b) Panel B2 designed for strain of 0.0080  
loaded to strain of 0.0079.

Figure 3.- Photographs of moiré-fringe patterns for typical undamaged panels during compression tests.

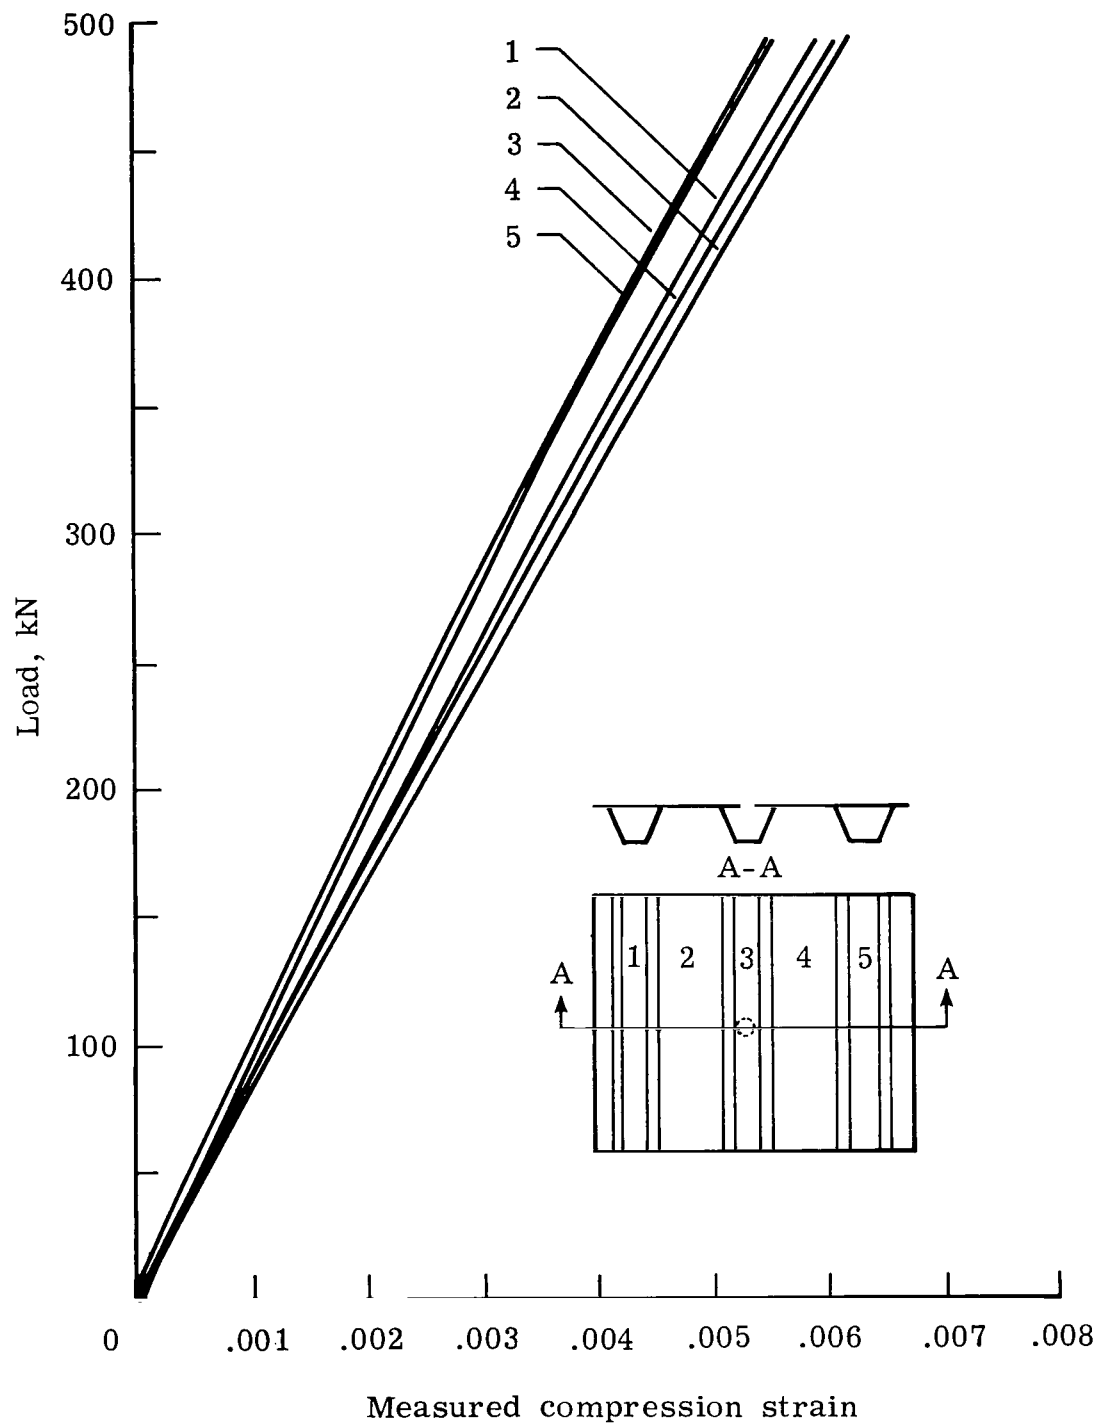
Panel with a cutout.- Panel B5 with the 1.27-cm-diameter cutout was loaded to failure in axial compression. Far-field axial strains were measured during the test by five strain gages located on a line across the panel, 6.35 cm from the cutout center. The locations of those gages and the strains as a function of load are shown in figure 4. These data indicate a nearly uniform far-field axial strain distribution across the panel and a linear load-strain relationship to failure. The average of these gages is referred to in this paper as the applied strain. Panel failure occurred at an applied strain of 0.0058 (applied load of 496 kN) which is 73 percent of the 0.0080 design strain.

Figure 4.- Compression load-strain curves at five locations across panel B5 which has 1.27-cm-diameter cutout in high-axial-stiffness region of center stiffener.

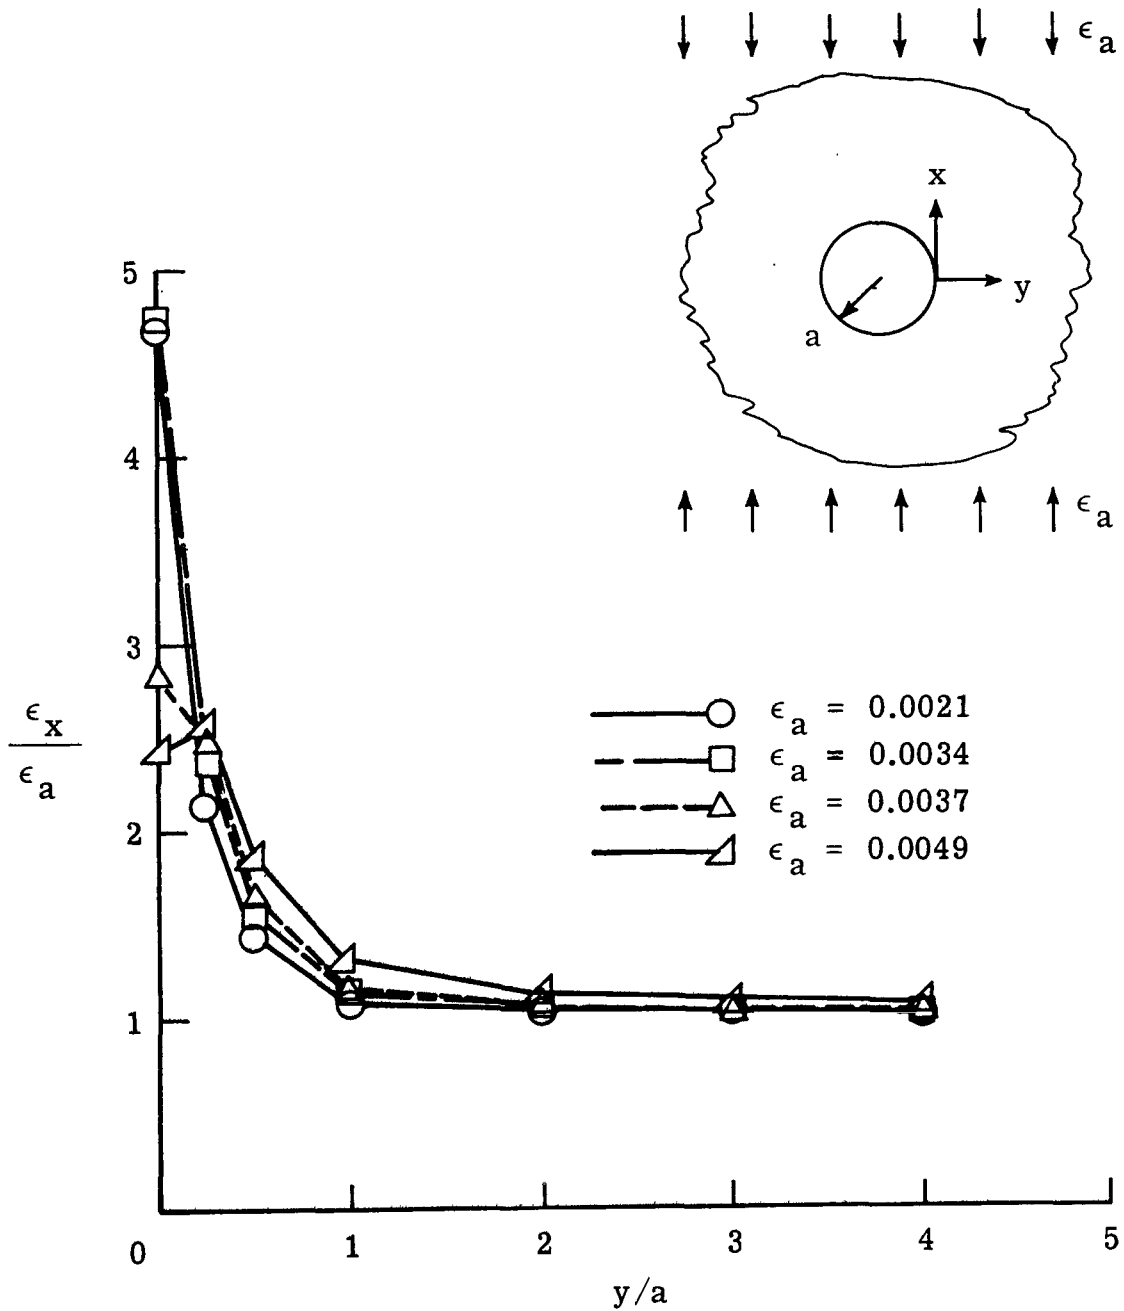
cutout and one gage was located on the cutout free-edge surface. The distribution of strain as determined by these gages across the right side of the panel normalized by the applied strain is shown in figure 5. The strains are several times greater near the cutout edge than those 3 cutout radii away and there are steep strain gradients near the cutout edge. Up to an applied strain of about 0.0034 the strain at the cutout edge is approximately 4.6 times greater than the far-field strain. At an applied strain of 0.0034 the strain at the cutout edge was initially 0.016 and then dropped suddenly to 0.012. It is suspected that a local material failure occurred at this very high strain level. At applied strains between 0.0034 and 0.0049 the strains at the cutout edge were only 2.4 to 2.8 times as great as the far-field strains as indicated by the results shown in figure 5.

Figure 5.- Strain measured in vicinity of 1.27-cm-diameter cutout on panel B5 ( $\epsilon_x$  denotes measured strain at indicated location at applied axial strain  $\epsilon_a$ ).

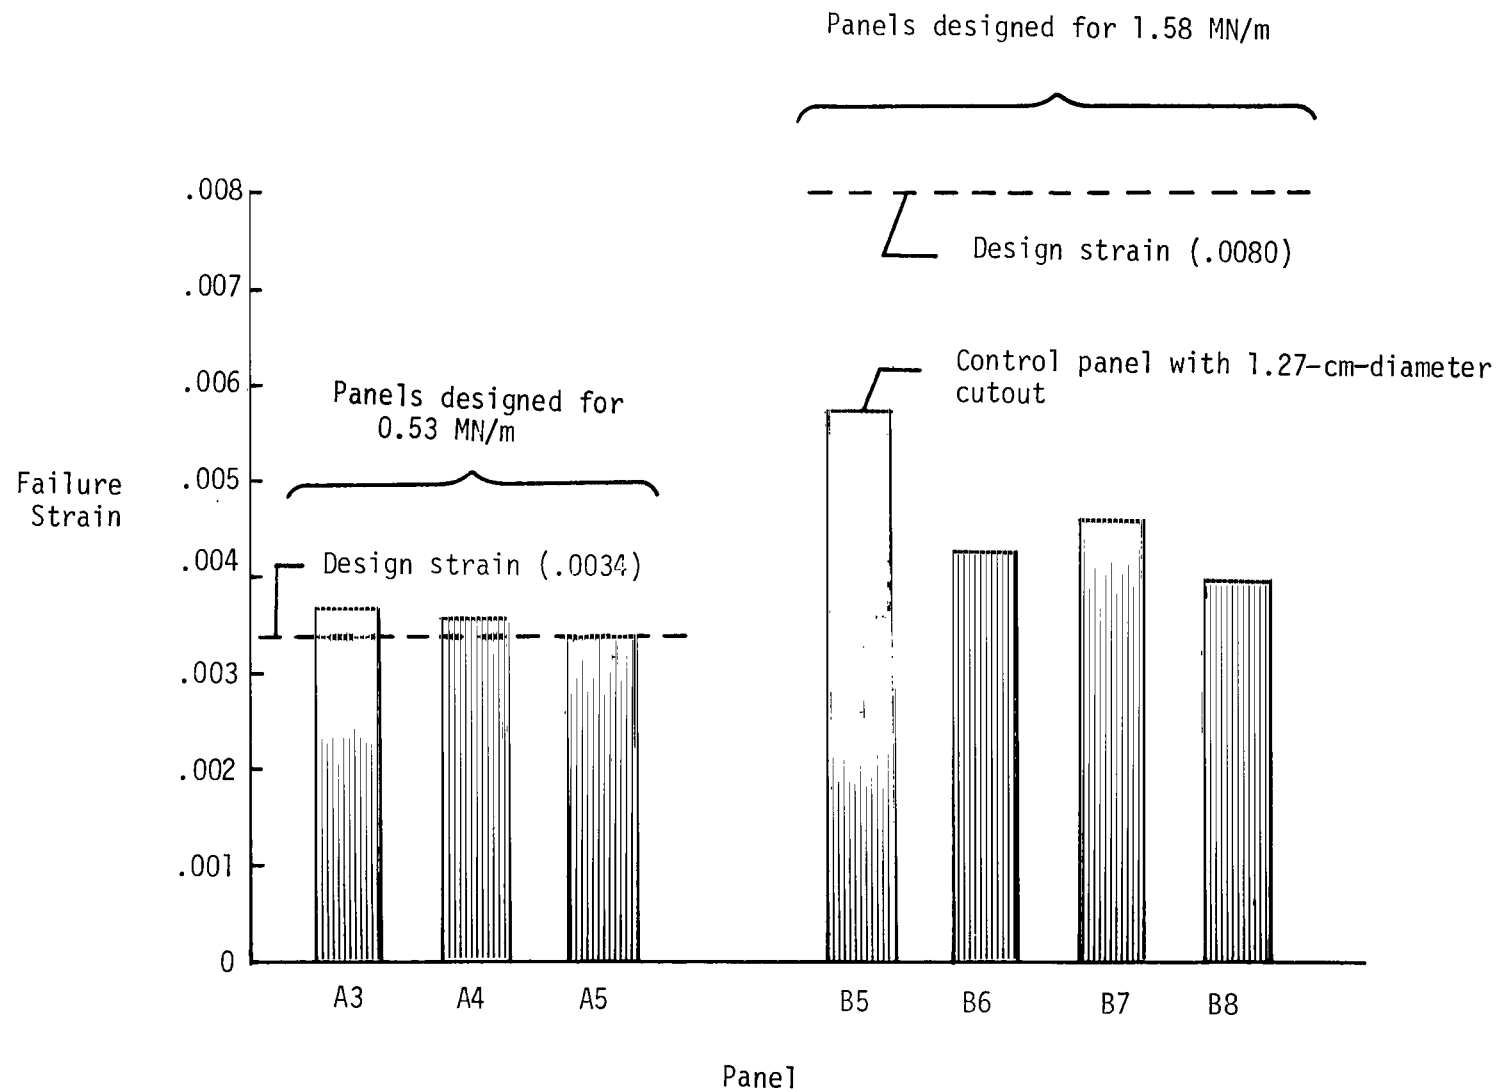
Impact-damage characterization: A comparison of test results for impact damage in the high-axial-stiffness region indicates both similarities and differences in the results for panels of design A and design B. The extent of local damage induced by impact increased with the magnitude of applied axial-compression strain for both designs. The design A panels satisfied the design-strain requirements with the presence of impact damage and also exhibited post-buckling behavior. The design B panels, however, failed due to impact damage at applied axial strains between 50 and 58 percent of the design strain level. Failure strains for impact-damaged panels and the control panel with circular cutout can be compared in figure 12. Limited local impact damage that was not noticeable by visual inspection (panel B6) reduced the ultimate strength of the design B panels as much as extensive visible localized damage (panel B7). All three of the design B panels damaged by impact failed at lower applied strain levels than the control test panel with the 1.27-cm-diameter cutout. The damaged region caused by impact, however, was larger than the cutout. For all design B panels the damage in the high-axial-stiffness region precipitated failure at an applied strain well below the design strain level.

Figure 12.- Failure strains for panels damaged by impact in high-axial-stiffness region and for control panel.
